SPACE SHUTTLE ORBITER  
APPROACH AND LANDING TEST  
FINAL EVALUATION REPORT

NATIONAL AERONAUTICS AND SPACE ADMINISTRATION  
LYNDON B. JOHNSON SPACE CENTER  
HOUSTON, TEXAS  
February 1978

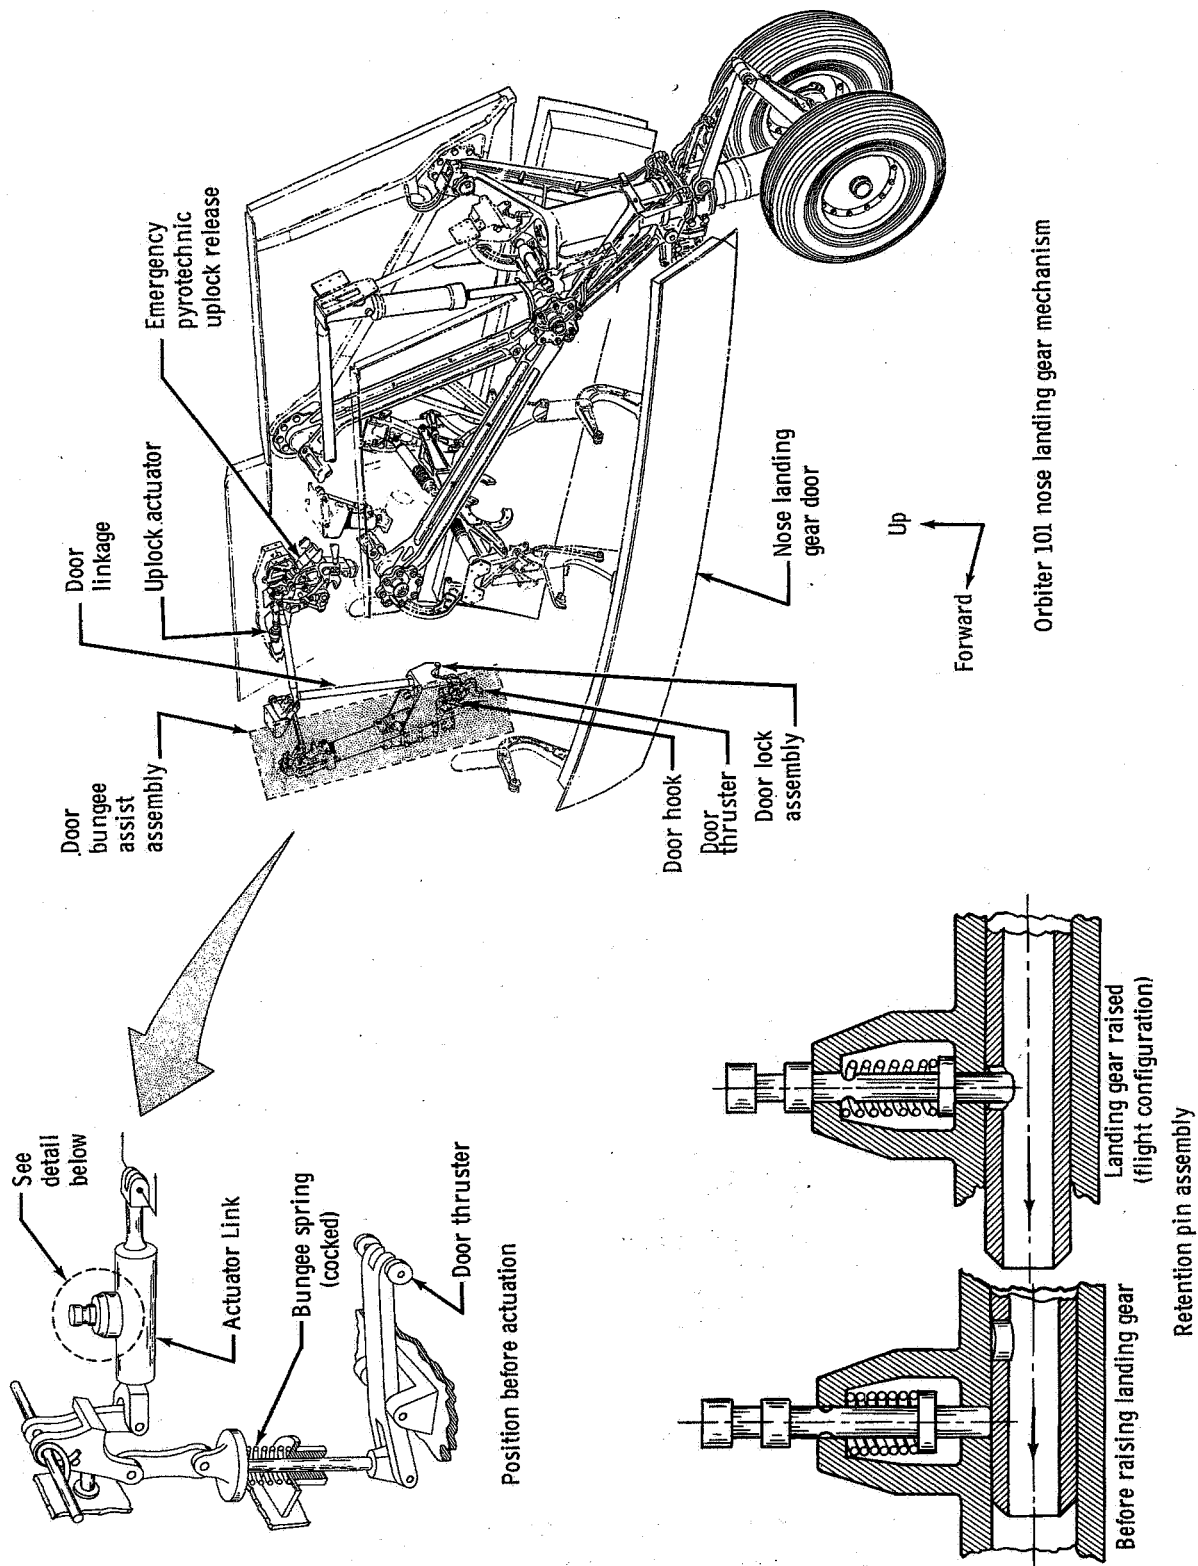
Figure 7-2. - Redesign concept for actuation of nose landing gear door thruster.

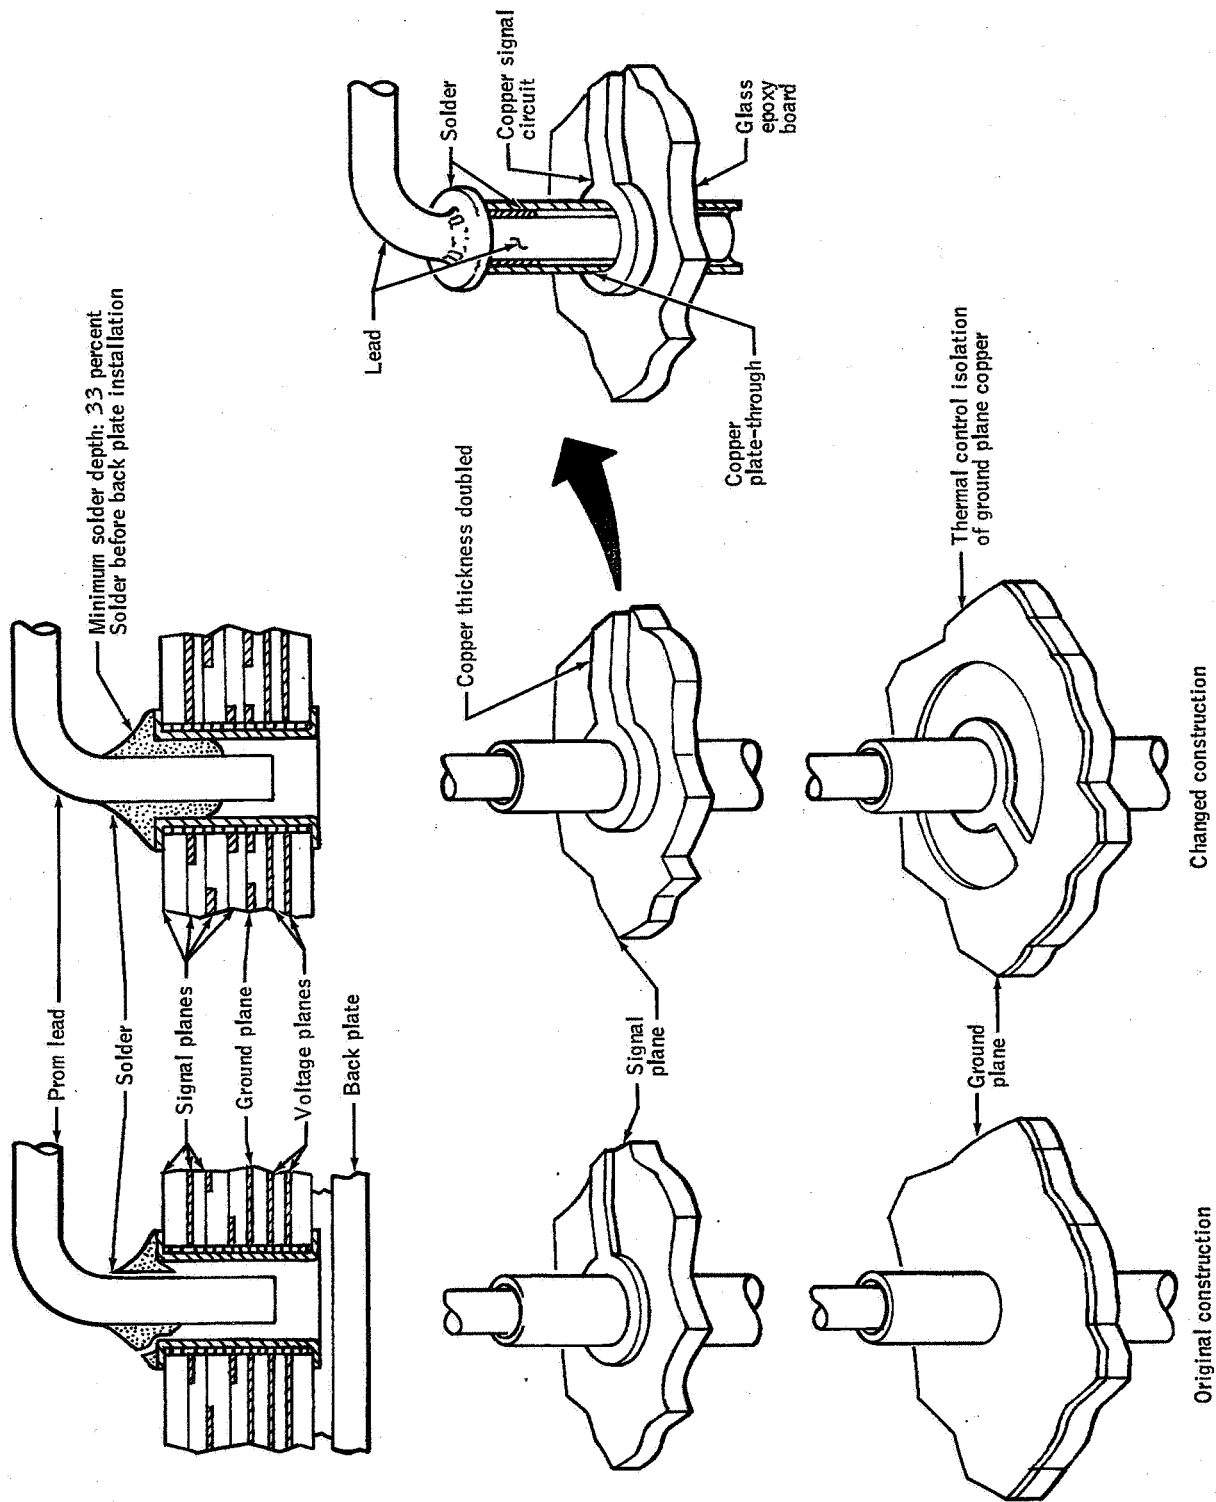
In-line changes had been implemented to circumvent this kind of problem, but not in time to be applied to system F8. Using the old verification procedure, the crowded page configuration made even oblique X-ray examination of some solder joints unsatisfactory for verification of the complete page. To correct this situation, the procedure was modified so that component X-ray inspection of solder wetting is accomplished before back-plate installation. Other changes

Figure 7-3. - Change in computer page lead connections to improve solder wicking.

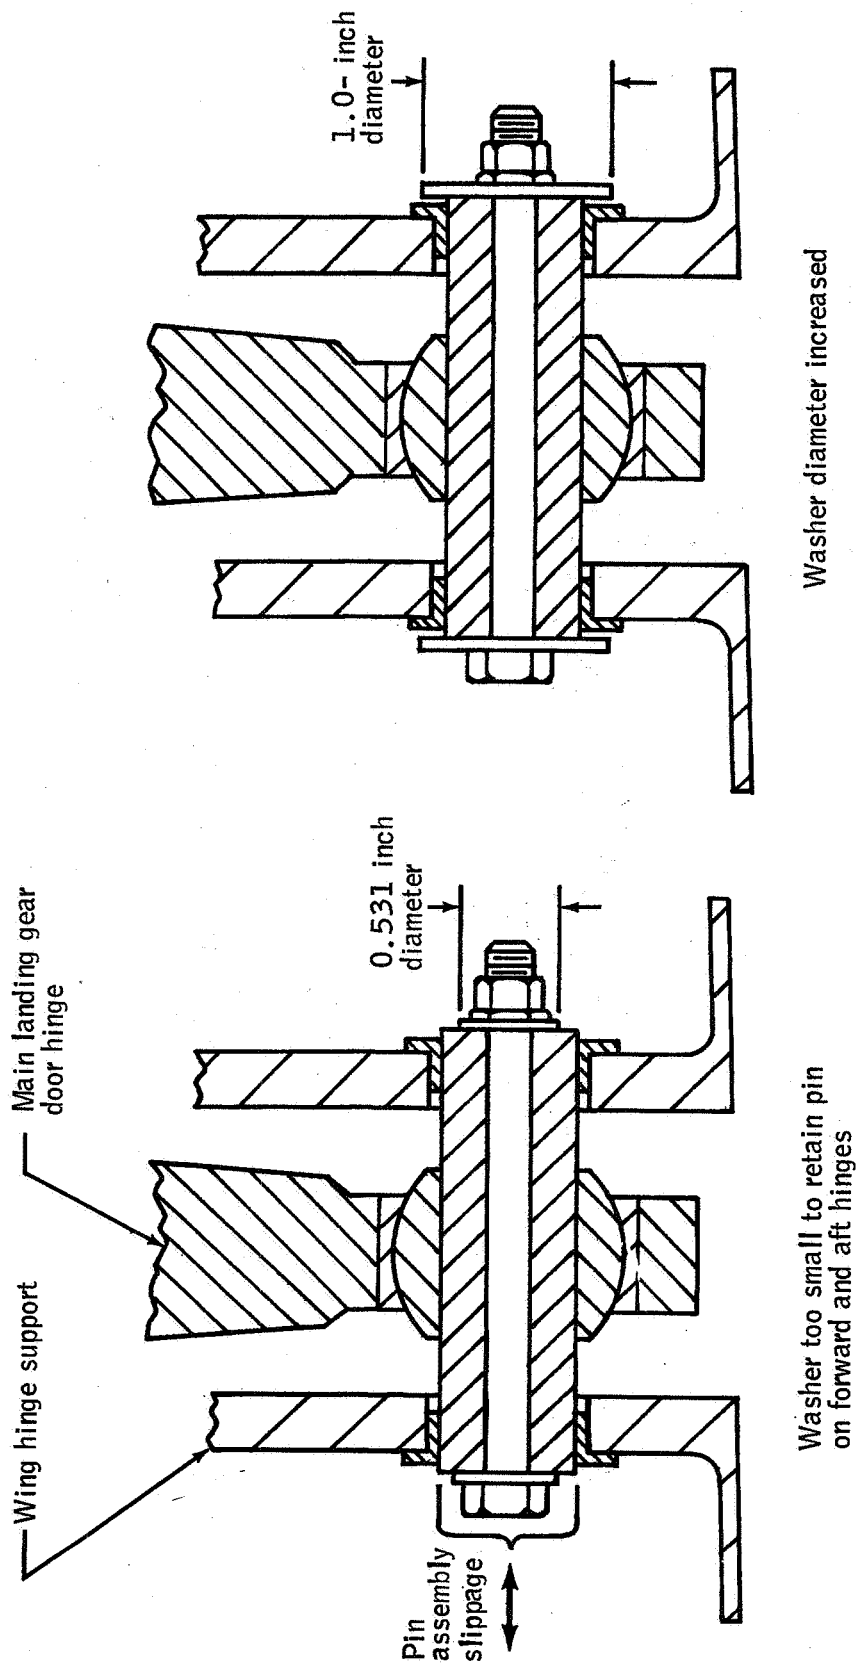
Figure 7-4. - Main landing gear door hinge assembly.

Main landing gear door hinge pin assembly: A main landing gear door hinge pin assembly was found missing after free flight 1. This anomaly is discussed in paragraph 7.2.3.

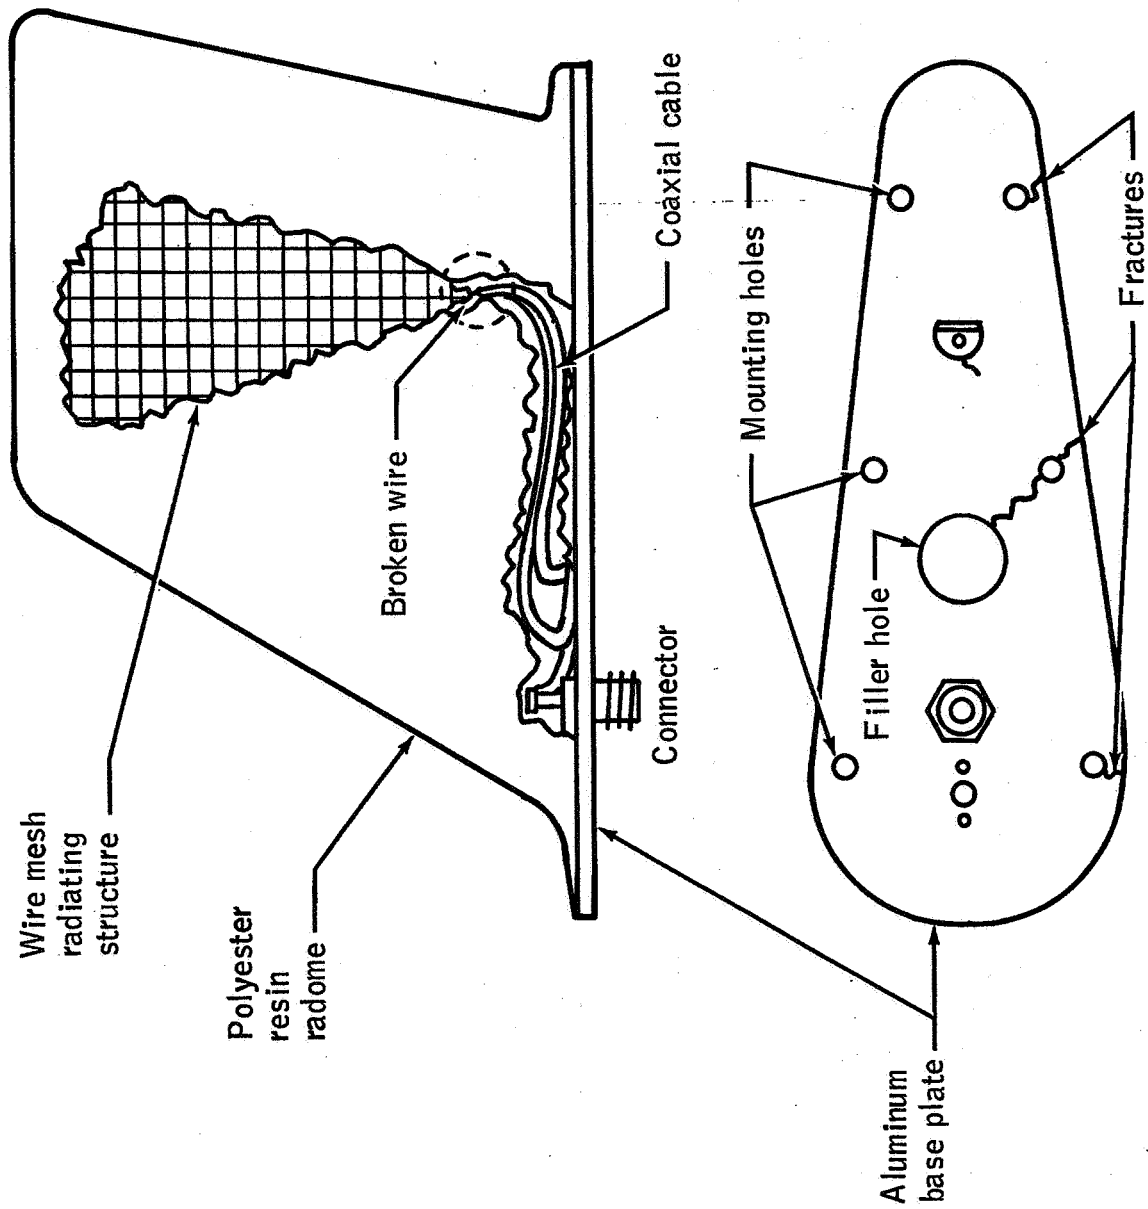
Figure 7-5.- UHF blade antenna failure on Free Flight 1.

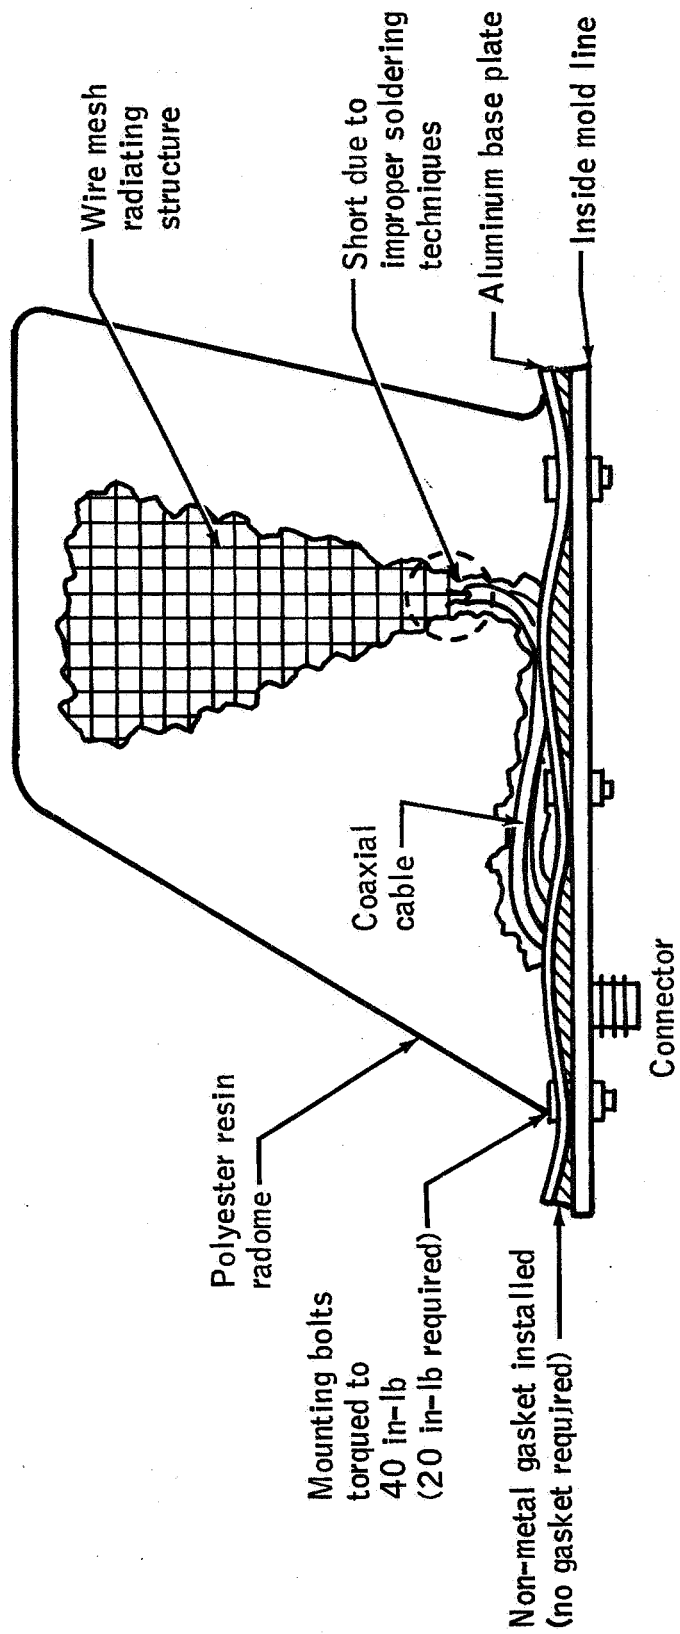
Figure 7-6.- UHF blade antenna failure on Free Flight 3.
